OBSERVATIONS ON THE BEHAVIOR OF BUILDINGS IN THE ROMANIA EARTHQUAKE OF MARCH 4, 1977

NBS SPECIAL PUBLICATION 490

Observations are presented of the damage to buildings resulting from the earthquake of March 4, 1977 in Romania. The report was prepared by engineers from the National Bureau of Standards who participated as members of the U.S. government team dispatched to Romania under the auspices of the Office of Foreign Disaster Assistance, Agency for International Development. A summary of the team's activities is included. Background data on the seismic history of Romania, the characteristics of the earthquake and descriptions of damage to specific buildings are also included. The types of building construction and the history of the development of seismic design requirements for buildings in Romania are discussed. Recommendations are presented for needed building research based on the observations.

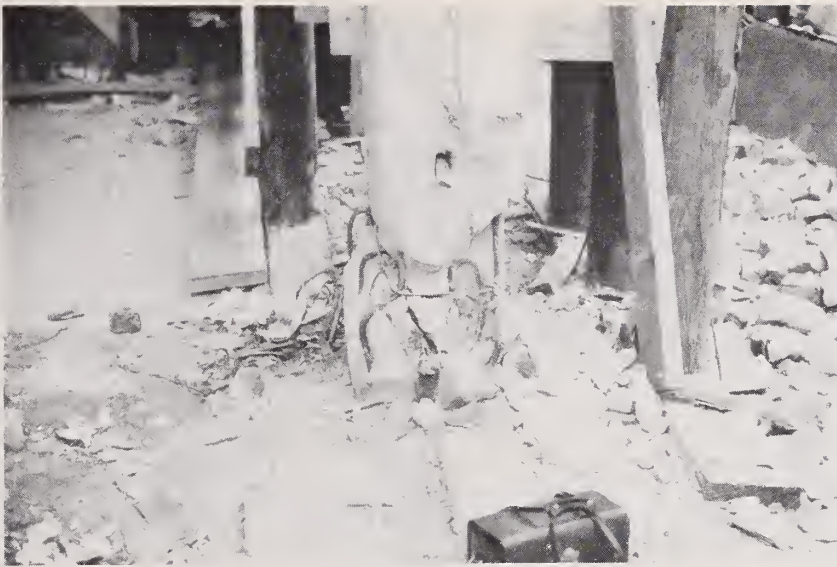
The failure of an interior column (Figure 3.20) exposed four vertical bars, approximately 20mm in diameter, and a single tie, approximately 6mm in diameter, spaced from the base a distance equal to the depth of the column. Four hooked footing dowels projected into the base of the column. The column that failed in shear (Figure 3.21), did not appear to have any ties within the height of the spalled concrete which was twice the depth of the column. All bars were plain.

Figure 3.20. Failure of interior first story column at the base indicating lateral displacement.

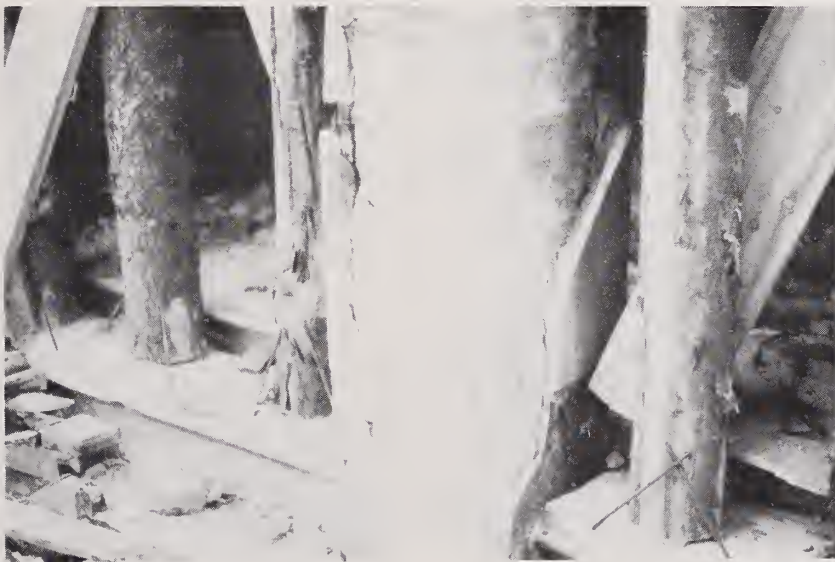
Figure 3.21. Shear failure at the base of first story interior column.

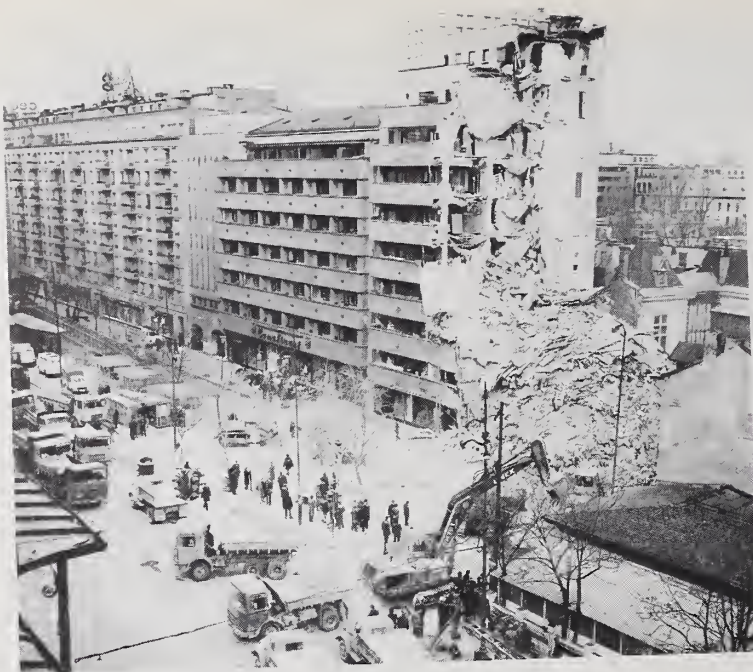
Figures 3.22 to 3.26 show the partial collapse of a 10-story building which is the end unit of a block of buildings along the east side of Boulevard Magheru. General views of the building before and after removal of the debris are shown in Figures 3.22 and 3.23, respectively. The wreckage in Figure 3.22 indicates extensive pulverization of the concrete, which was observed at other sites as well.

Figure 3.22. General view of the collapse of the end bays of Casata building.

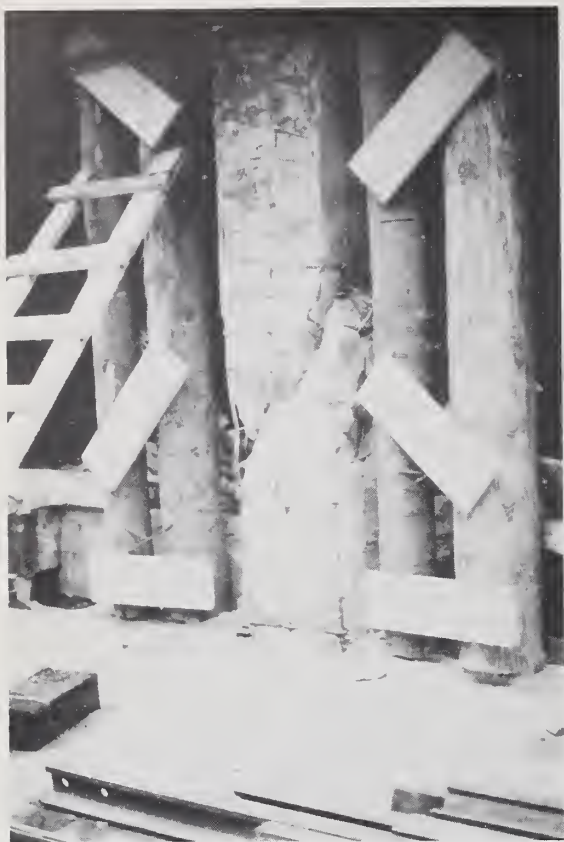
Figure 3.26 shows shear failure observed in an interior first story column. A total of six vertical bars were used in the column, three in each face, and approximately 16mm in diameter. The single ties were approximately 6mm in diameter and were bent only around the corner bars. In general, concrete cover was insufficient and at certain locations non-existent. Note, for instance, that on the unspalled top surface of the column, ties as well as vertical bars are visible with one of the ties inclined 15 degrees with respect to the horizontal.

Figure 3.26. Damage to interior column in the first floor.

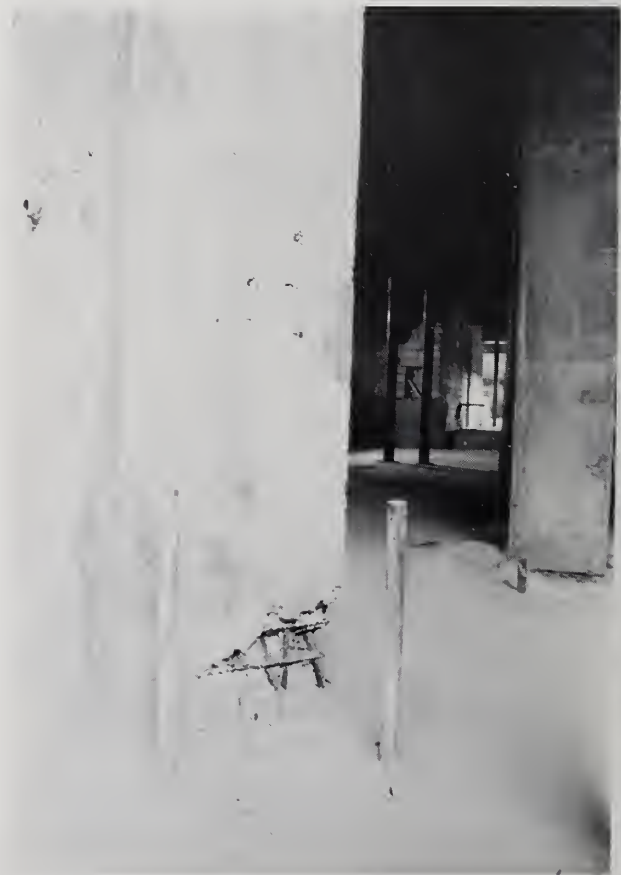
Figure 3.67. Damage at the base of first story interior column.

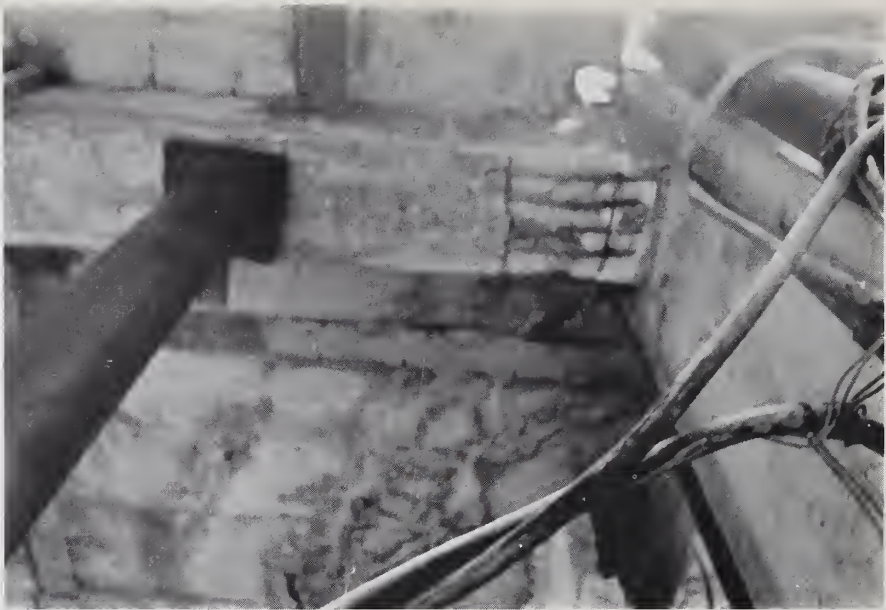
Figure 3.70. Failure of transverse beam at the support.

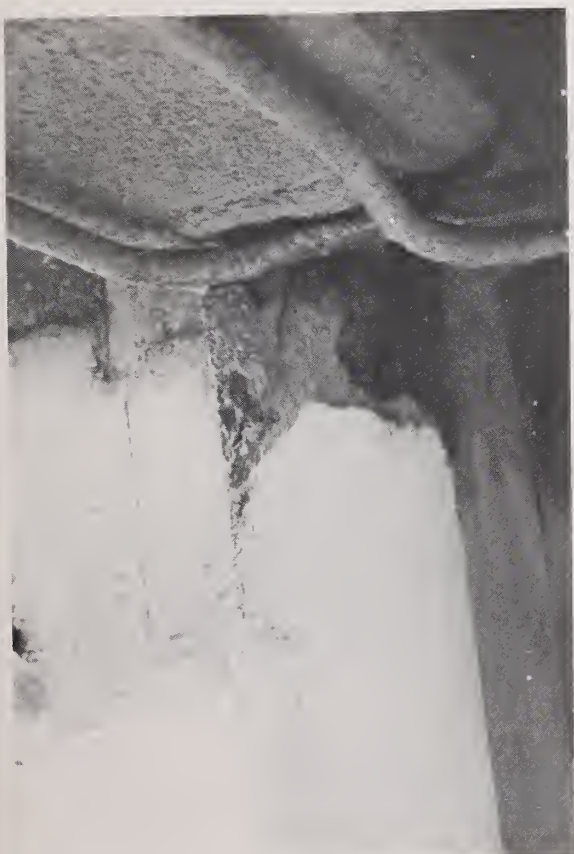
Figure 3.73. Damage at the top of first story column.

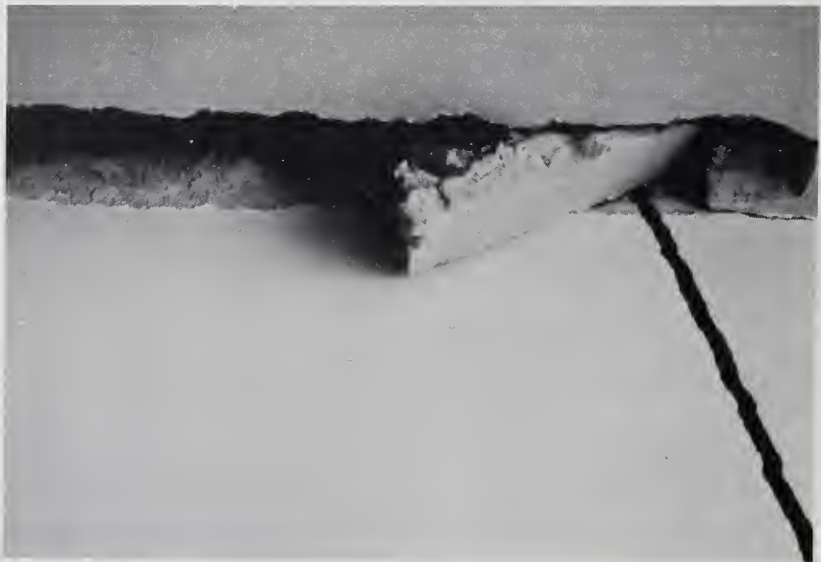
Figure 3.75. Detached masonry units between ceiling and wall.

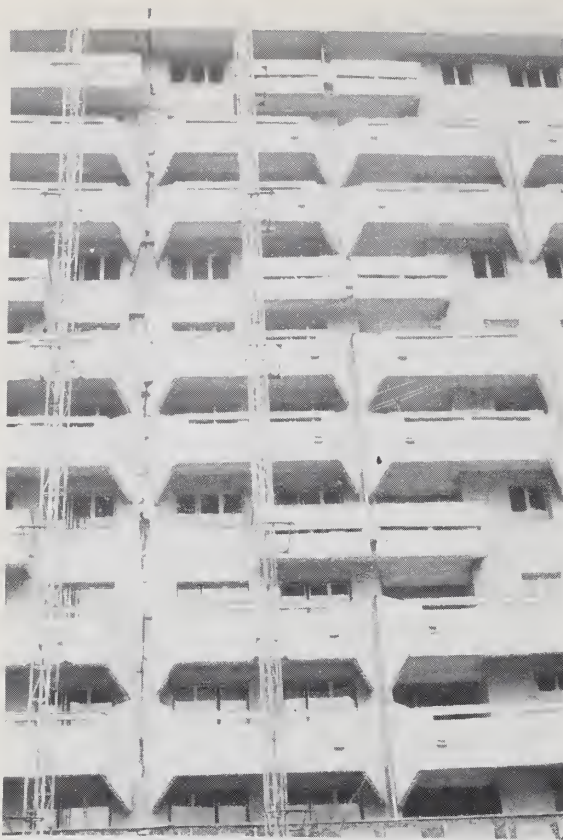
Figure 3.82. Pounding damage to adjacent buildings.

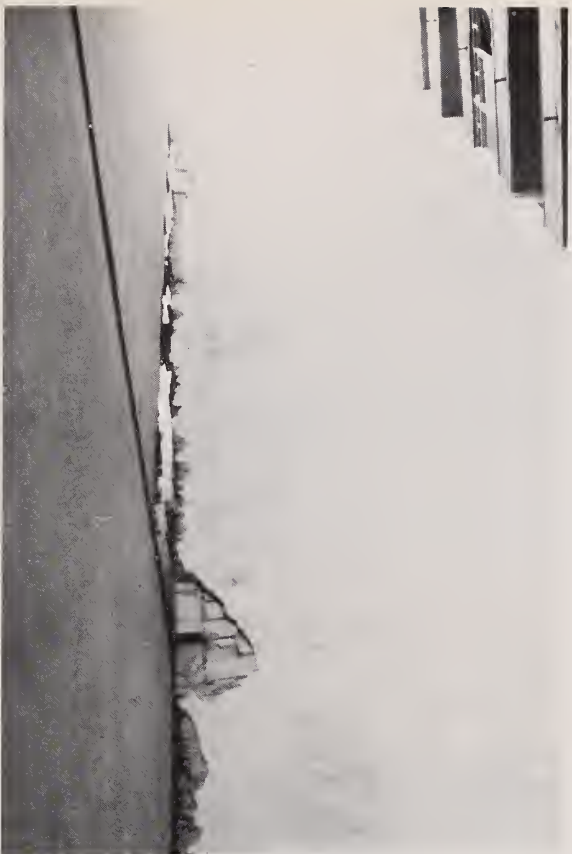
Figure 3.84. Same pounding damage viewed from the opposite side.

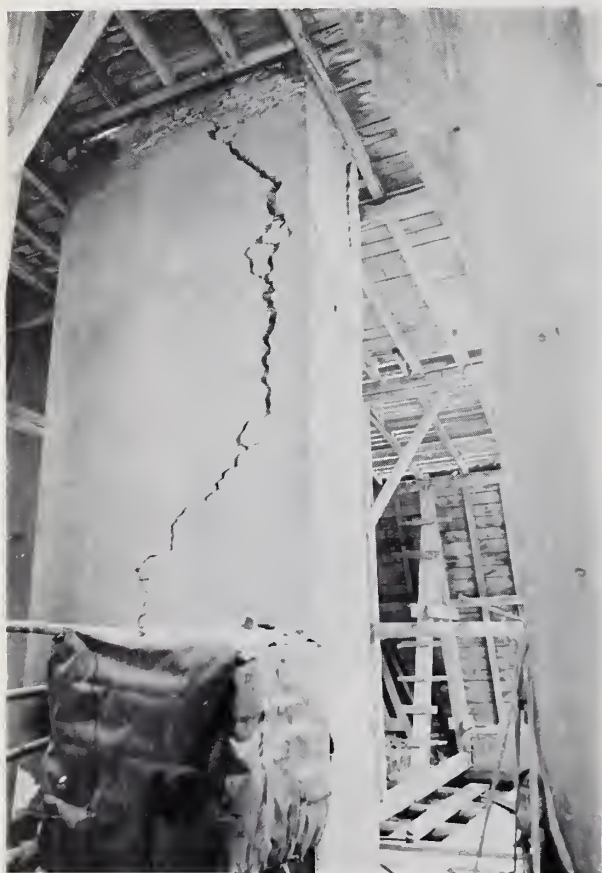
Figure 3.103. Ruptured masonry chimney in the museum attic.
